[Docket No. 2002-SW-54-AD; Amendment 39-13087; AD 2003-05-11]

Airworthiness Directives; Bell Helicopter Textron Canada Model 407 Helicopters

2003-05-11 Bell Helicopter Textron Canada: Amendment 39-13087. Docket No. 2002-SW-54-AD. Supersedes Emergency AD 2002-23-51, Docket No. 2002-SW-51-AD.

Applicability: Model 407 helicopters, serial numbers 53000 through 53538, certificated in any category.

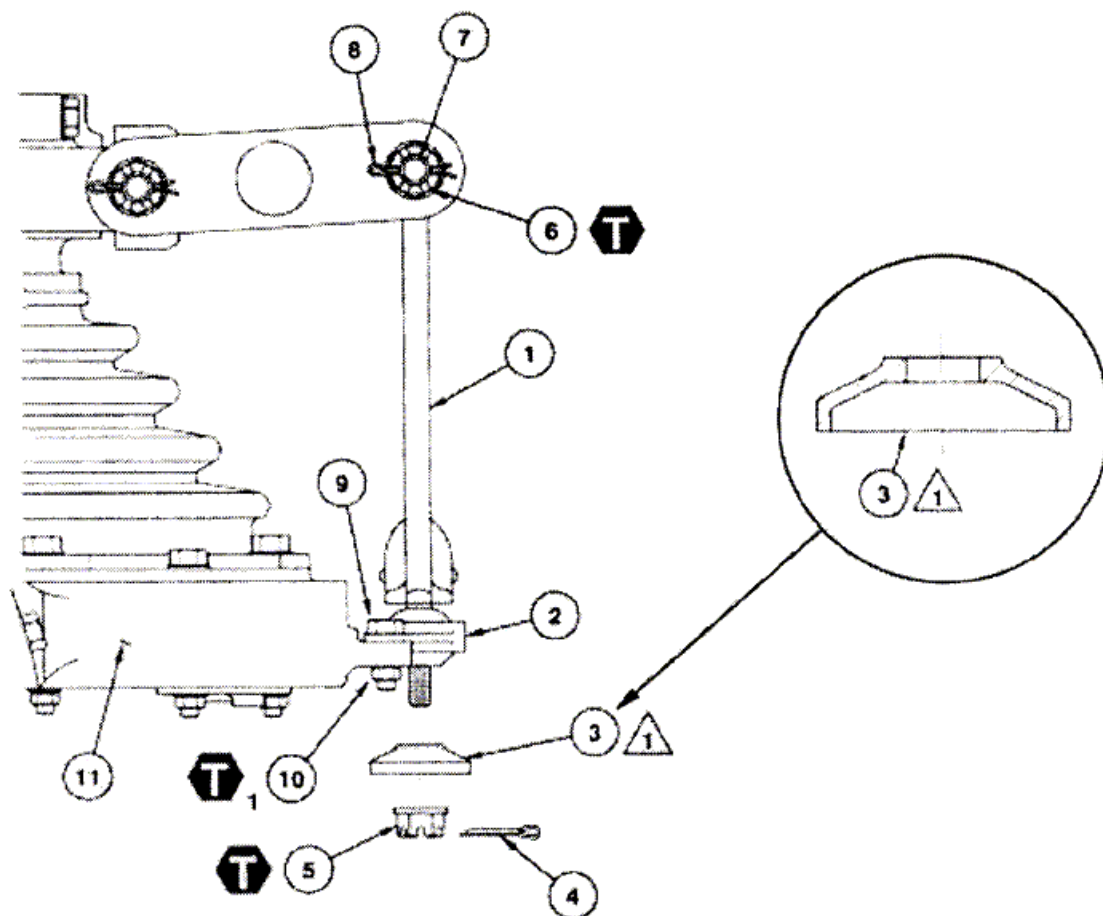
Figure 1. Correct cup washer direction, installation of

To detect an incorrectly installed swashplate drive link cup washer (cup washer), which could limit the travel of the swashplate outer ring and lead to failure of the stud portion of the swashplate drive link, and subsequent loss of control of the helicopter, accomplish the following:

- 1** Washer shown is correctly installed.
2. Washers under bolt head (9) and nut (10) are not shown for clarity.

(a) Visually check both cup washers, part number (P/N) 406-010-412-101, for correct installation in accordance with Figure 1 of this AD. If both cup washers are installed correctly, no further action is required. This visual check may be performed by an owner/operator (pilot) holding at least a private pilot certificate, and must be entered into the aircraft records showing compliance with this paragraph in accordance with sections 43.11 and 91.417(a)(2)(v) of the Federal Aviation Regulations (14 CFR sections 43.11 and 91.417(a)(2)(v)). See the following Figure 1:

(b) If a cup washer is installed incorrectly, remove and replace the swashplate outer ring, each cup washer, bearing and liner, and drive link where the cup washer was installed incorrectly. Replace these parts in accordance with Part II of the Accomplishment Instructions in Bell Helicopter Textron Alert Service Bulletin No. 407-02-55, dated October 29, 2002.

Note 2: In Part II, step 3.a. of the alert service bulletin, the swashplate is incorrectly referenced as item 10 of Figure 1. The reference should state item 11.
